Earthquakes from a radiological perspective: what is demanded from the radiologists, and what can we do? A pictorial review

Sonay Aydin¹
 Omer Kazci²
 Bunyamin Ece³
 Mecit Kantarci¹

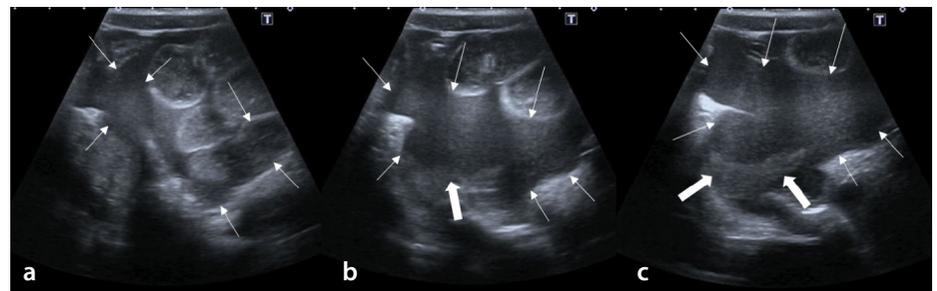
Figure 2. Intra-abdominal hemorrhage. The patient was trapped for 12 hours by earthquake debris. Eight-year-old boy, Focused Assessment with Sonography for Trauma ultrasonography images. (a) Axial view of the lower abdominal quadrant, diffuse free fluid with multiple internal echogenicities is seen between the inframezocolic bowel loops (thin arrows); (b, c) in more inferior sections, free fluid (thin arrows) with multiple internal echogenicities in the lower abdomen/pelvic region. Fluid–fluid leveling within the hemorrhage (thick arrows).

Focused Assessment with Sonography for Trauma (FAST) is the main sonographic method for earthquake-related ailments (Figure 2). After Hurricane Katrina, 9/11 in New York, the Lebanon War in 2006, and the Iran earthquake in 2010, FAST was found to be successful in assessing and triaging patients during

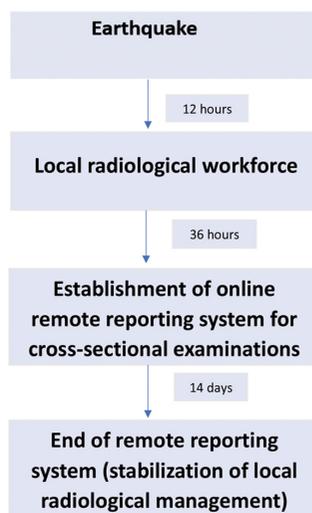
Figure 3. Workload management after the earthquake.

Serious difficulties have been experienced in accessing radiological images during disasters. For this reason, the ideal reporting method is verbal reporting if there is an opportunity to work closely with the clinician. In cases where there is no opportunity to work in close contact, written reports that provide short and concise information and that can be created quickly come to the forefront.⁶ After the recent earthquake disaster, it is satisfying that a system that allows remote, fast, and effective reporting was established very quickly (Figure 3).

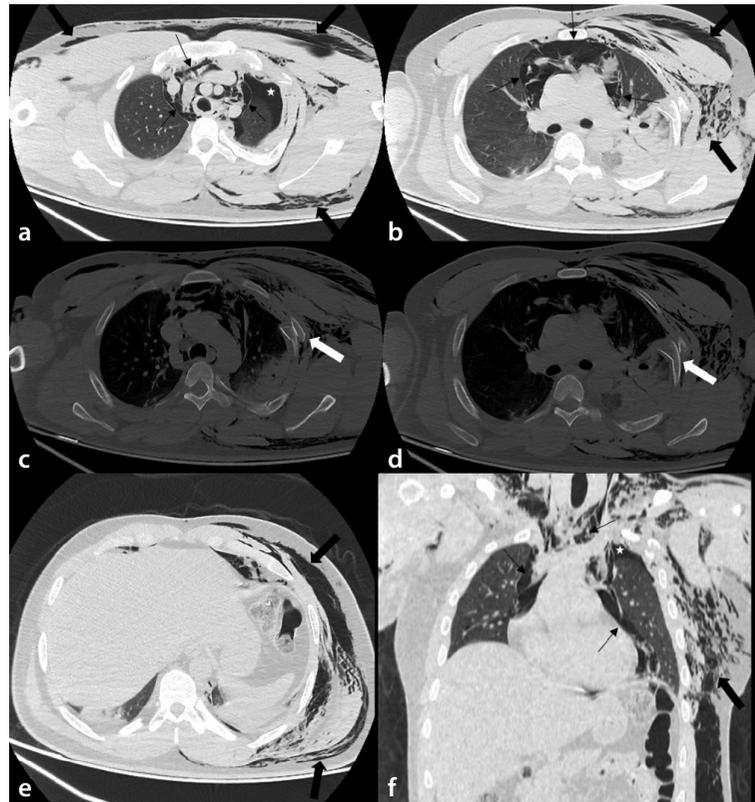
Figure 4. Traumatic pneumothorax, pneumomediastinum the patient was trapped for 19 hours by earthquake debris. Forty-three-year-old male. (a) On the axial images passing through the upper thoracic region, multiple air densities in the mediastinum (thin black arrows, pneumomediastinum), air densities near the left lung upper lobe (asterisk, pneumothorax), and diffuse subcutaneous emphysema more dominantly in the left hemithorax are seen (thick black arrows). (b) Pneumomediastinum (thin black arrows) and diffuse subcutaneous emphysema (thick black arrows) are seen in the axial sections passing through the middle part of the thorax. (c, d) Displaced rib fracture and extension of bone fragment into lung parenchyma on bone window axial section images are seen (thick white arrows). (e) Diffuse subcutaneous emphysema (thick black arrows) is seen in the axial sections passing through the inferior part of the thorax. (f) Pneumomediastinum (thin black arrows), pneumothorax (asterisk) and diffuse subcutaneous emphysema (thick black arrows) are seen in the coronal images.

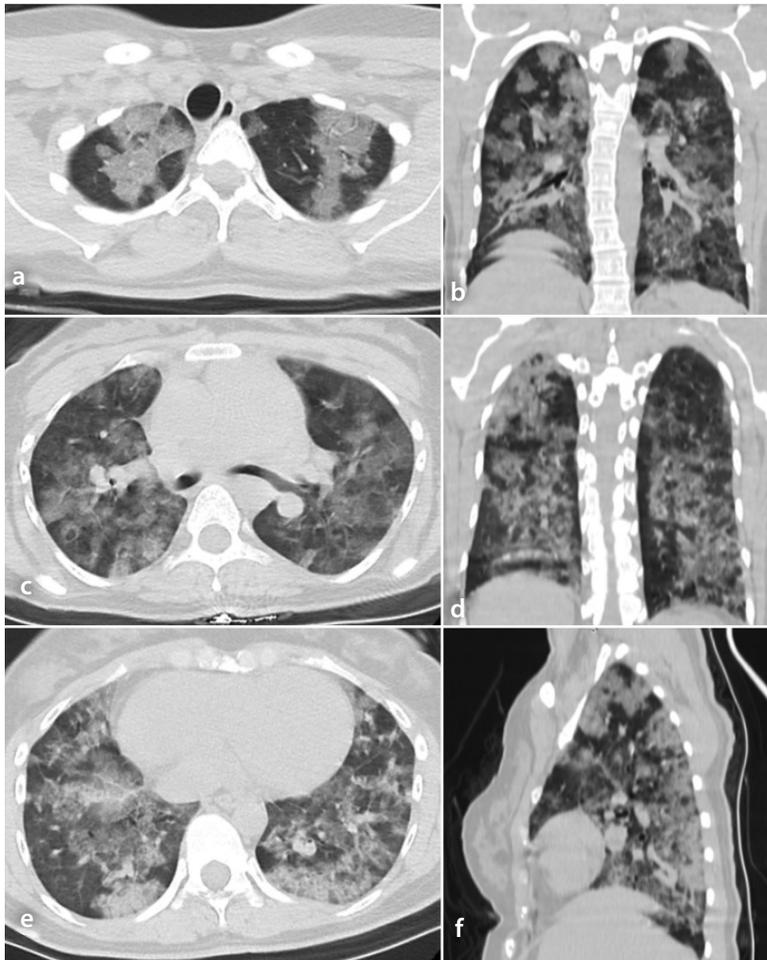
Figure 5. Diffuse alveolar hemorrhage. The patient was trapped for 22 hours by earthquake debris. Forty-three-year-old male. Diffuse widespread ground glass opacities and consolidations. (a, c, e) Axial images from different levels; (b, d) coronal images from different levels; (f) sagittal.

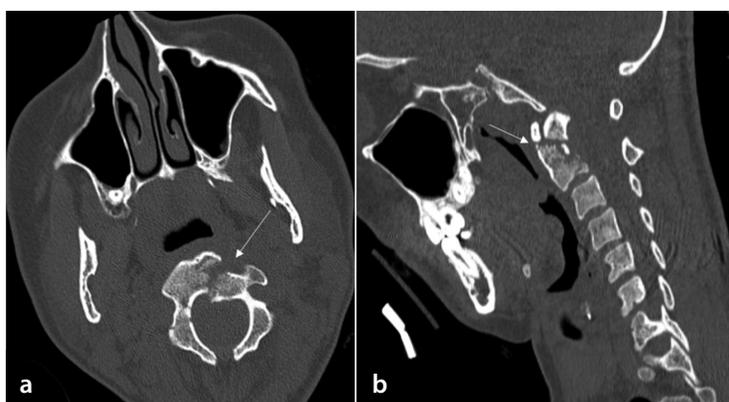
Figure 6. Type 2 odontoid fracture. The patient was trapped for 9 hours by earthquake debris. Thirty-nine-year-old male. A fragmented and displaced fracture of the odontoid process (arrows) is seen on axial (a) and coronal (b) computed tomography images.

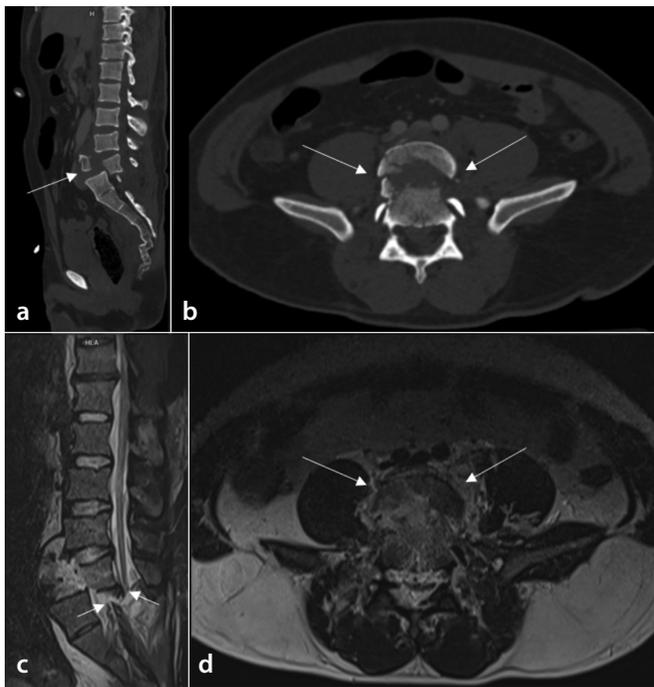
Figure 7. Traumatic listhesis and spinal cord injury. The patient was trapped for 31 hours by earthquake debris. Forty-one-year-old male. Retrolisthesis due to burst fracture of the L5 vertebrae (arrows) on the L5-S1 level. Spinal cord transection is seen on coronal Short tau inversion recovery (STIR) (c, arrows point to the two dissected edges of the spinal cord) (a) coronal computed tomography (CT) image, (b) axial CT image, (c) coronal STIR, (d) axial T2 weighted image.

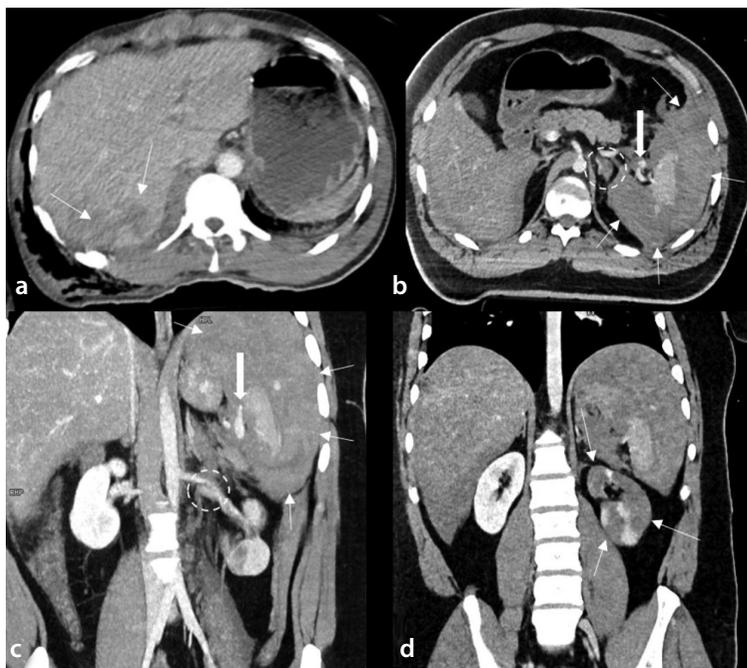
Figure 8. Different patterns of traumatic abdominal injury. The patient was trapped for 35 hours by earthquake debris. Forty-seven-year-old male (a) American Association for the Surgery of Trauma (AAST) grade III injury in the right lobe-segment VII. (b) Left surrenal hematoma (circle), large perisplenic hematoma (arrows), splenic arterial injury, and corresponding contrast medium extravasation (thick arrow) (AAST grade V injury). (c) Large perisplenic hematoma (arrows), splenic arterial injury, and corresponding contrast medium extravasation (thick arrow). Sudden luminal narrowing in the left renal artery (circle) observed secondarily to blunt trauma. (d) Renal parenchymal infarct (arrows) due to the arterial narrowing shown in d (AAST grade V injury).

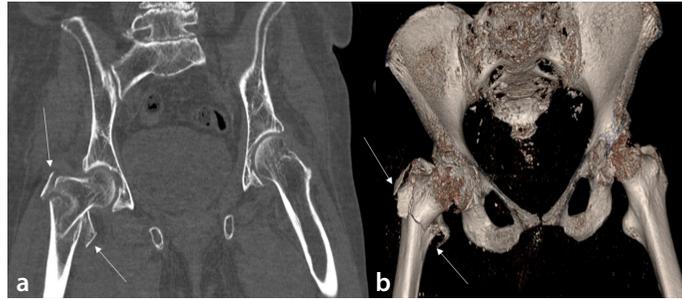
Figure 9. Intertrochanteric femur fracture. It was not possible to determine how long the patient was trapped by earthquake debris. Thirty-eight-year-old male. Displaced and comminuted fracture (arrows) in the right femoral intertrochanteric region on the coronal (a) and three-dimensional reconstruction (b) computed tomography images.

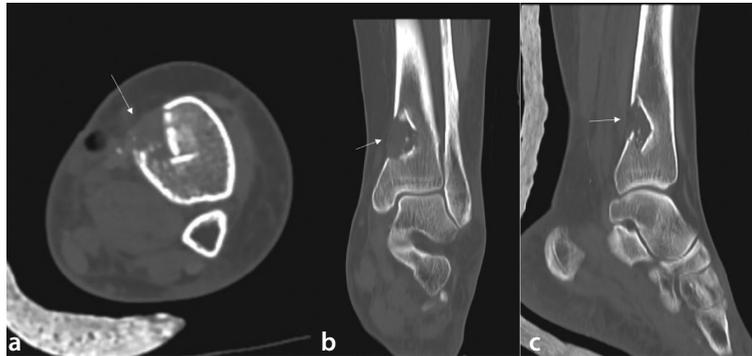
Figure 10. Distal tibial fracture. It was not possible to determine how long the patient was trapped by earthquake debris. Thirty-year-old male. (a) Medial cortical depression and internal displaced fracture (arrow) are seen in the distal metaphyseal–diaphyseal part of the tibia on axial (a), coronal (b), and sagittal (c) computed tomography images.

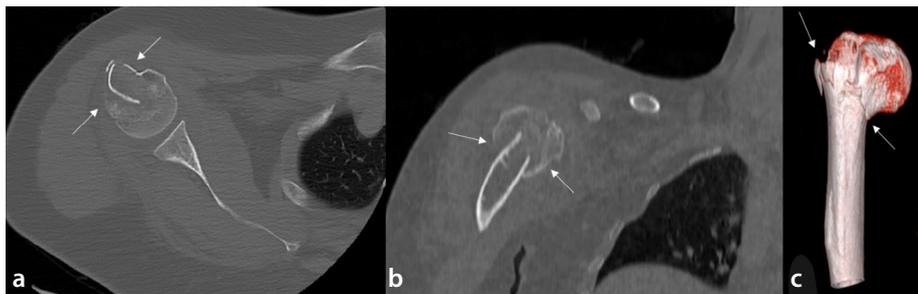
Figure 11. Proximal humeral fracture. It was not possible to determine how long the patient was trapped by earthquake debris. Sixty-year-old female. Fracture is seen in the surgical neck of humerus fracture (arrows) (a: axial view, b: coronal view, c: three-dimensional image).

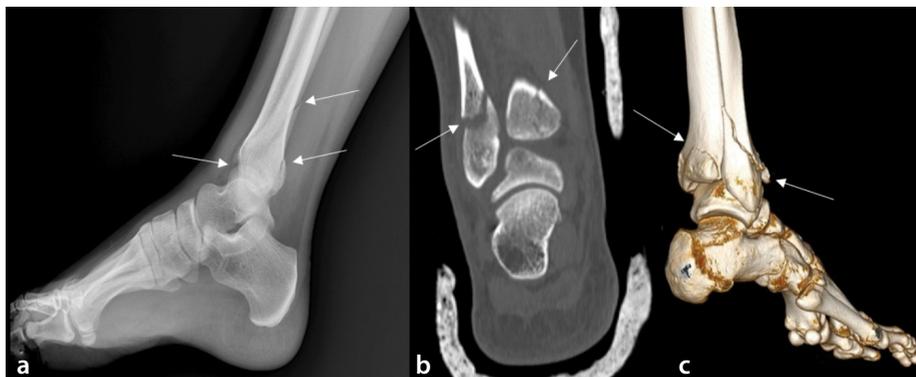
Figure 12. Multiple lower extremity fractures. The patient was trapped for 23 hours by earthquake debris. Thirty-three-year-old male. Minimally displaced fractures are present in the medial malleolus of the tibia and distal metaphysis of the fibula on X-ray (a), coronal computed tomography (b), and three-dimensional reconstruction (c) images.

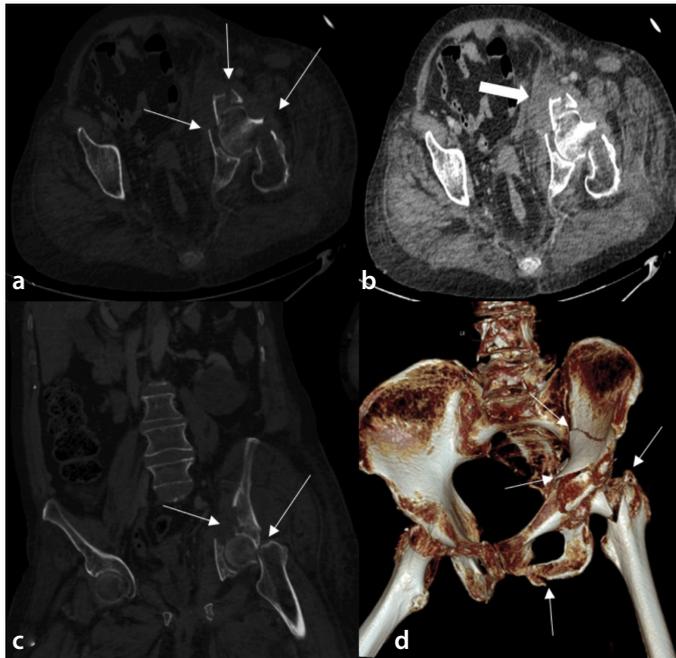
Figure 13. Pelvic and humeral fractures. The patient was trapped for 29 hours by earthquake debris. Seventy-six-year-old male. Displaced and comminuted fractures are seen in the left acetabulum and femoral neck (thin arrows) on axial (a) and coronal (c) computed tomography (CT) images. Large intramuscular hematoma due to the fractures is present on axial CT image (b, thick arrow). The fractures extend towards the iliac wing and inferior pubic ramus on the three-dimensional reconstruction image (d, arrow, Tile type A2 fracture).

Pelvic fractures are generally seen as multiple and bilateral (Figure 13). In a study conducted in China, the most common pelvic fracture subtype was reported as type C, followed by type B3 and type B2.¹⁹ In a study conducted in Turkey, type C2 fractures were found most frequently, similar to the Chinese data (Table 1).^{20,21}

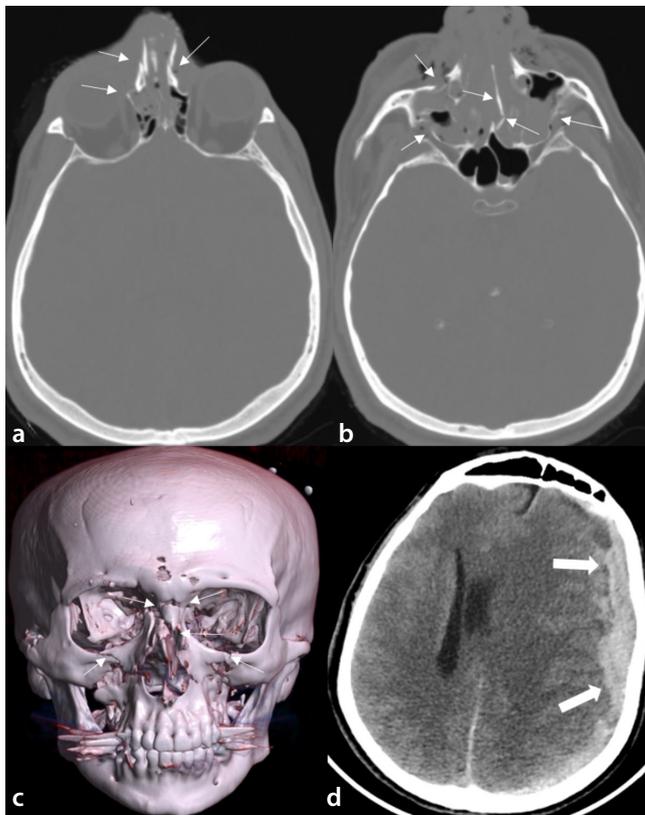
Figure 14. Multiple maxillofacial fractures and accompanying cranial hemorrhage. The patient was trapped for 17 hours by earthquake debris. Forty-four-year-old male. Multiple displaced fractures (thin arrows) are seen in maxillofacial bones in axial (a, b) and 3D reconstruction (c) computed tomography images. Extensive subdural hemorrhage causing a shift in midline structures accompanies the fractures (d, thick arrows).

When the distribution of maxillofacial traumas is examined, it is seen that mandibular fractures are the most common, followed by the zygomatic complex and maxilla. Similar to lower extremity fractures, multiple and comminuted fractures are common. Cranial injuries and lower extremity fractures are the most common types of injuries to accompany maxillofacial fractures (Figure

14).^{22,23} Some studies report that nasal bone, ethmoid bone, and orbital fractures are also common. Maxillofacial fractures are injuries that require a multidisciplinary approach due to the complex anatomy of the region and the frequent occurrence of accompanying cranial traumas.²³

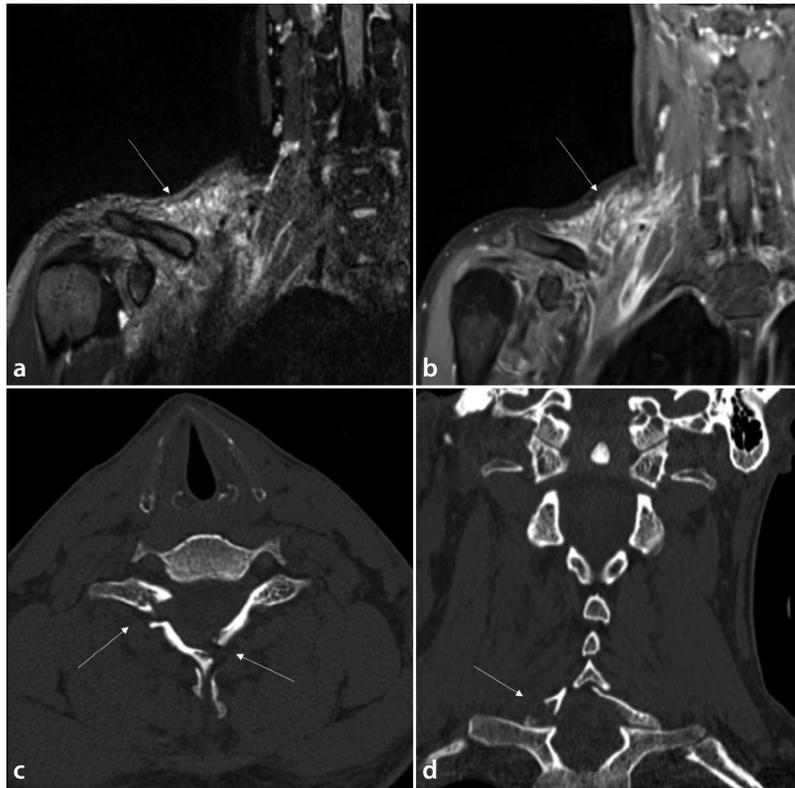
Figure 15. Rhabdomyolysis. The patient was trapped for 39 hours by earthquake debris. Twenty-year-old male. Rhabdomyolysis due to brachial plexus damage secondary to cervical fracture. Rhabdomyolysis (arrows) is seen as hyperintense on short tau inversion recovery (a) and it enhances on post-contrast T1 weighted image (b). The displaced fracture in the bilateral arch of the C7 vertebrae (arrows) is seen in axial (c) and coronal (d) sections on computed tomography.

occurs, two different patterns can be seen: (a) homogeneously iso/hyperintense on T1 weighted images (WI), homogeneously hyperintense on T2WI/short tau inversion recovery homogeneously enhancing on postcontrast T1WI, and (b) homogeneously/heterogeneously hyperintense on T1WI, heterogeneously hyperintense on T2WI, rim-like enhancement on postcontrast T1WI

(Figure 15).²⁴ Based on data from an experimental animal study, contrast-enhanced ultrasonography (CEUS) is effective in the prehospital or bedside diagnosis of rhabdomyolysis. The study revealed that, compared with uninjured muscles, injured muscles showed early and high enhancement in CEUS images.²⁵

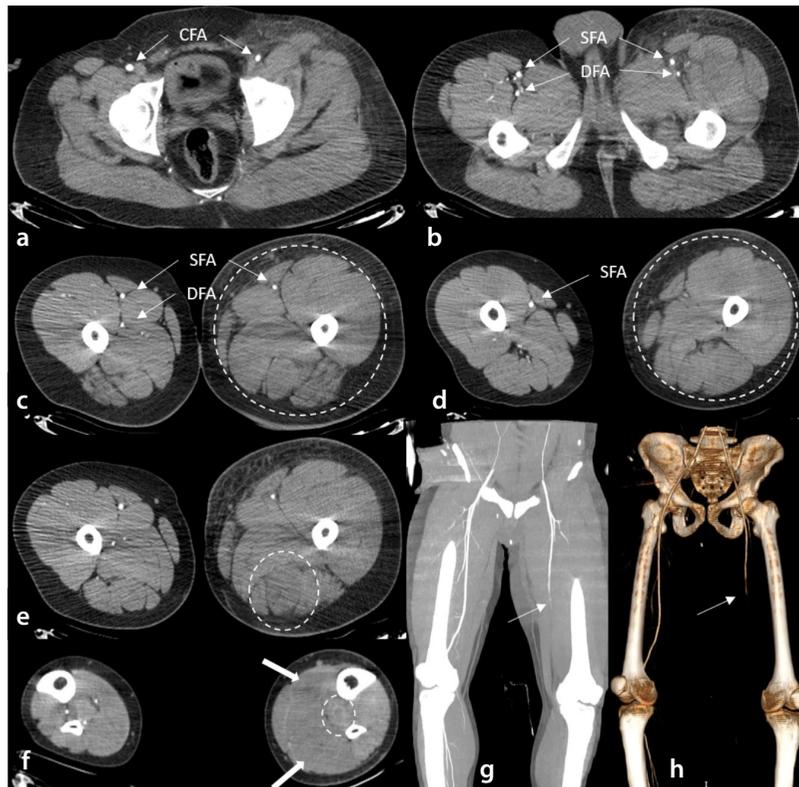
Figure 16. Compartment syndrome and rhabdomyolysis. The patient was trapped for 51 hours by earthquake debris. Thirty-four-year-old male. Left lower extremity is larger and subcutaneous edema is present (a-e). Common femoral artery, superficial femoral artery (SFA), and deep femoral artery are normal in the proximal segments of the left lower extremity (a-c). Due to increased intracompartmental pressure, left SFA narrows suddenly (d, g, h, arrows). Semitendinosus (e, circle) and gastrocnemius (f, arrows) muscles are hypodense; there is a ring-enhancing lesion in the popliteus muscle (f, circle) due to rhabdomyolysis.

Acute compartment syndrome is a surgical emergency that poses limb- and life-threatening risks. It is a painful condition brought on by increased intracompartmental pressure, which compromises perfusion and causes muscle and nerve damage inside the affected compartment. The diagnosis of acute compartment syndrome is based on clinical symptoms and measurements of compartmental pressures. Utilization of imaging techniques is often restricted, and in some instances, imaging can delay diagnosis and surgical therapy. In addition to the aforementioned signs of rhabdomyolysis, MRI reveals herniation of muscle through a tear in the surrounding fascia. In addition, CT angiography and color Doppler US can be utilized to detect vascular luminal constriction due to elevated intracompartmental pressure (Figure 16).^{26,27}

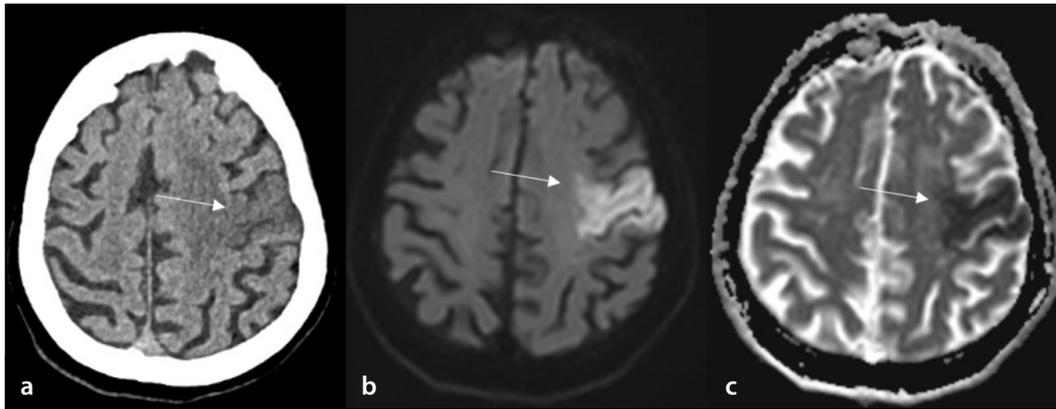
Figure 17. Acute cerebral infarction. Forty-four-year-old male, diagnosed 50 hours after being rescued from rubble. Ischemic brain parenchyma is seen as a hypodense area on computed tomography (a); corresponding diffusion restriction can be seen on diffusion-weighted imaging (b) and apparent diffusion coefficient map (c).

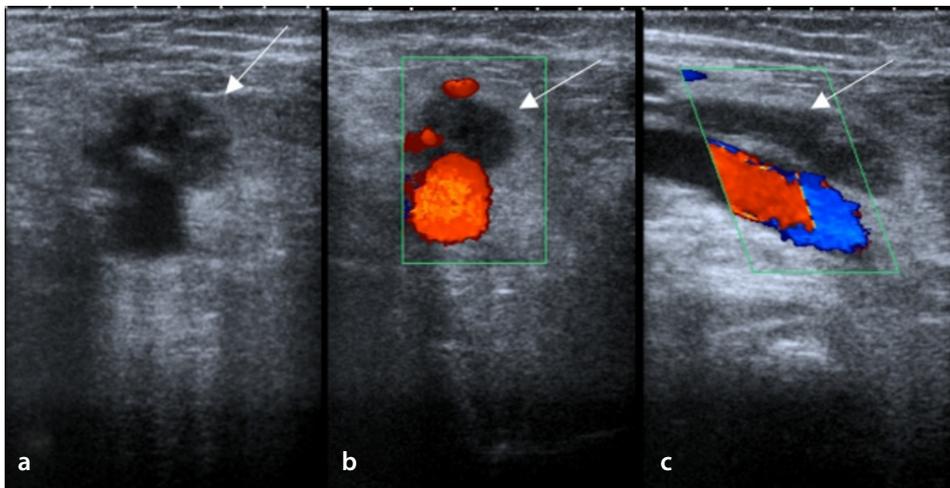
Figure 18. Deep vein thrombosis. Fifty-three-year-old female, diagnosed after rescue after 13 hours in the rubble. Thrombosis is seen in the superficial femoral vein (arrows) on grayscale ultrasound (a), axial (b), and longitudinal color Doppler ultrasonography images (c).

diseases associated with earthquakes (Figures 18, 19).^{30,31} While HF increases occur over long periods, such as into the seventh week

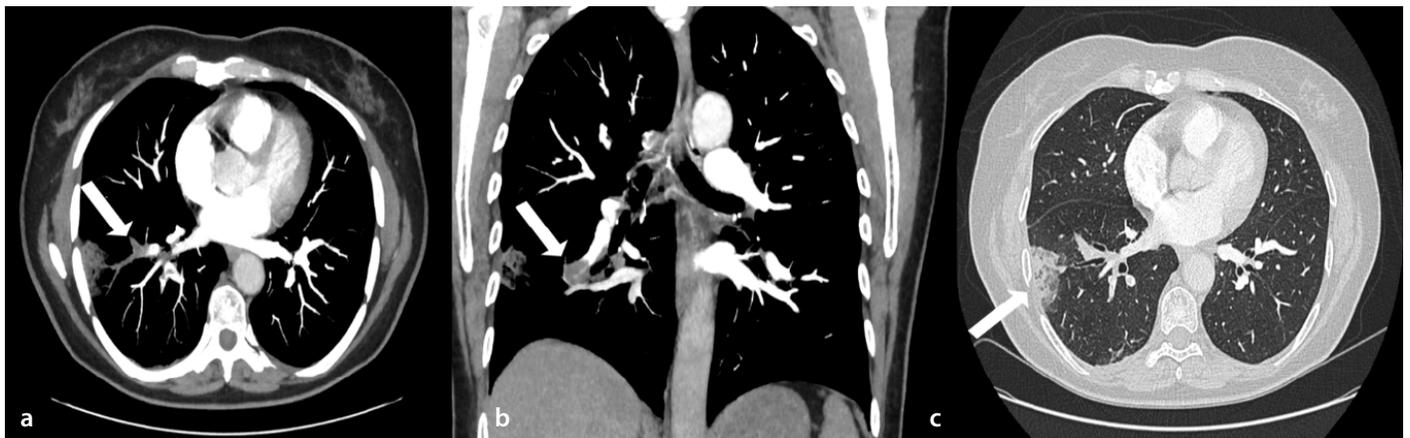
Figure 19. Pulmonary thromboembolism (PTE). The patient was trapped for 41 hours by earthquake debris. Forty-seven-year-old female. Filling defect corresponding to PTE, detected after 72 hours from the rescue from a rubble, is seen on axial (a, arrow) and coronal (b, arrow) images. A peripheral lung necrosis due to PTE is seen on the axial image with parenchymal windowing (c, arrow).

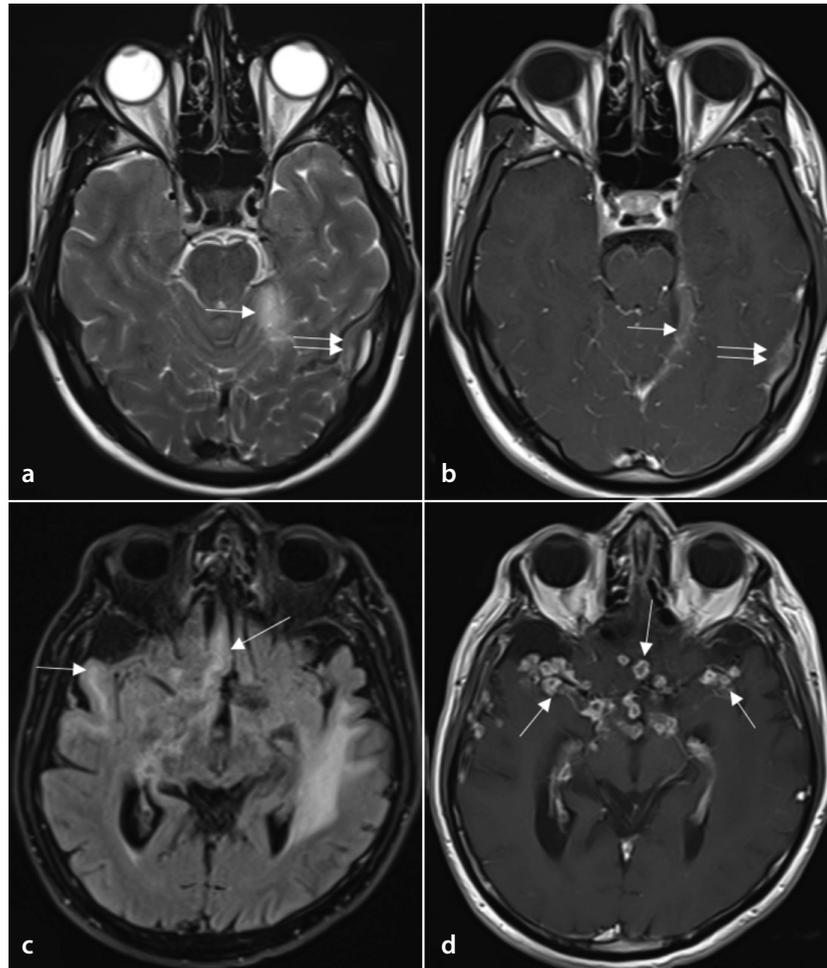
Figure 20. Viral meningitis (**a, b**) and tuberculous meningitis (**c, d**). Forty-three-year-old female and 73-year-old male, respectively. The images were obtained after 53 and 83 hours in the rubble, respectively.

Viral meningitis: left tentorium cerebelli is seen thickened and hyperintense on T2 weighted image (WI) (**a**, arrow), left temporal lobe and neighboring dura is hyperintense on T2WI (**a**, double arrow) (**a**), increased contrast enhancement is present in both corresponding areas (**b**).

Tuberculous meningitis: faint hyperintensities are present in the bilateral basal areas of the temporal lobes on fluid attenuated inversion recovery (**c**, arrows); increased contrast enhancement and ring-enhancing lesions can be seen in both corresponding areas (**d**, arrows).
